# Debris/Ice/TPS Assessment and Integrated Photographic Analysis of Shuttle Mission STS-71

*Gregory N. Katnik, Barry C. Bowen, J. Bradley Davis*

**27 June 1995**

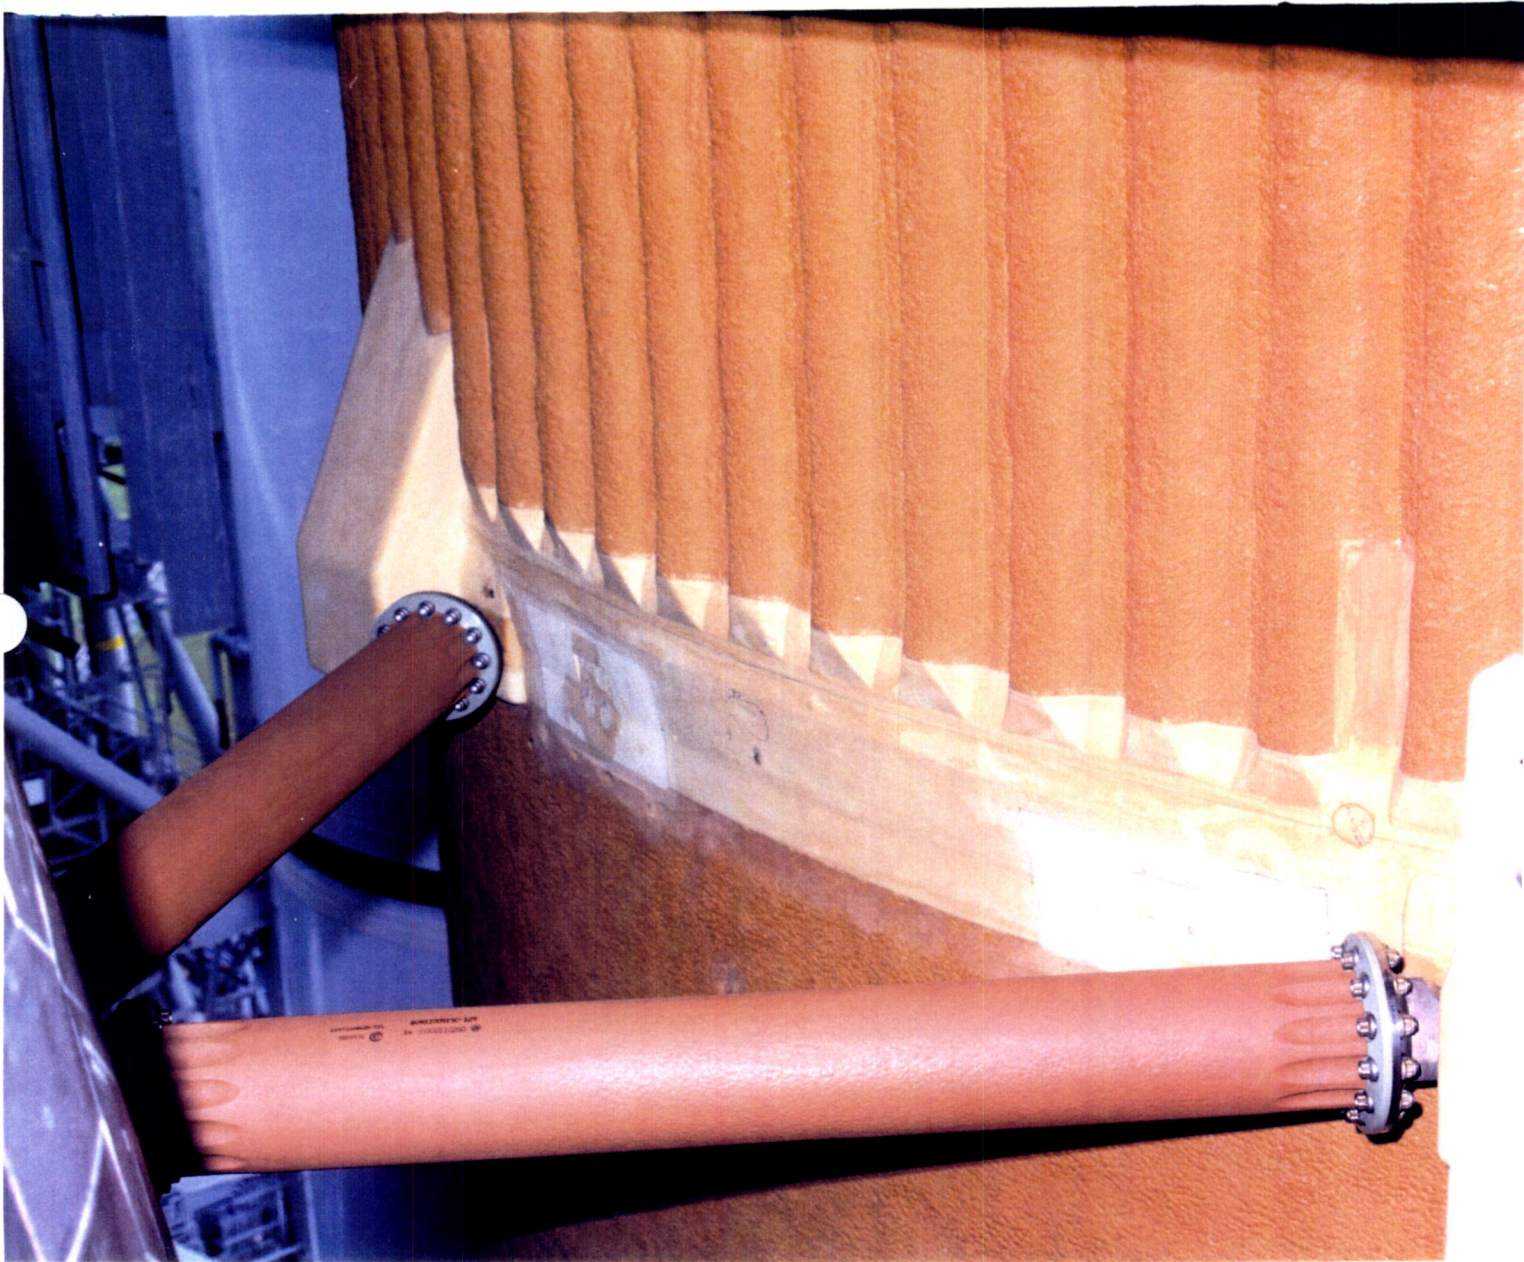
**Photo 2 : Redesigned Bipod Jack Pad Closeouts**  
First flight of the new jack pad closeouts on ET-70

Topcoat was loose/missing from the lower half of the -Y alignment grid and around the vent louver. The redesigned bipod jack pad closeouts were intact and flush with adjacent foam.

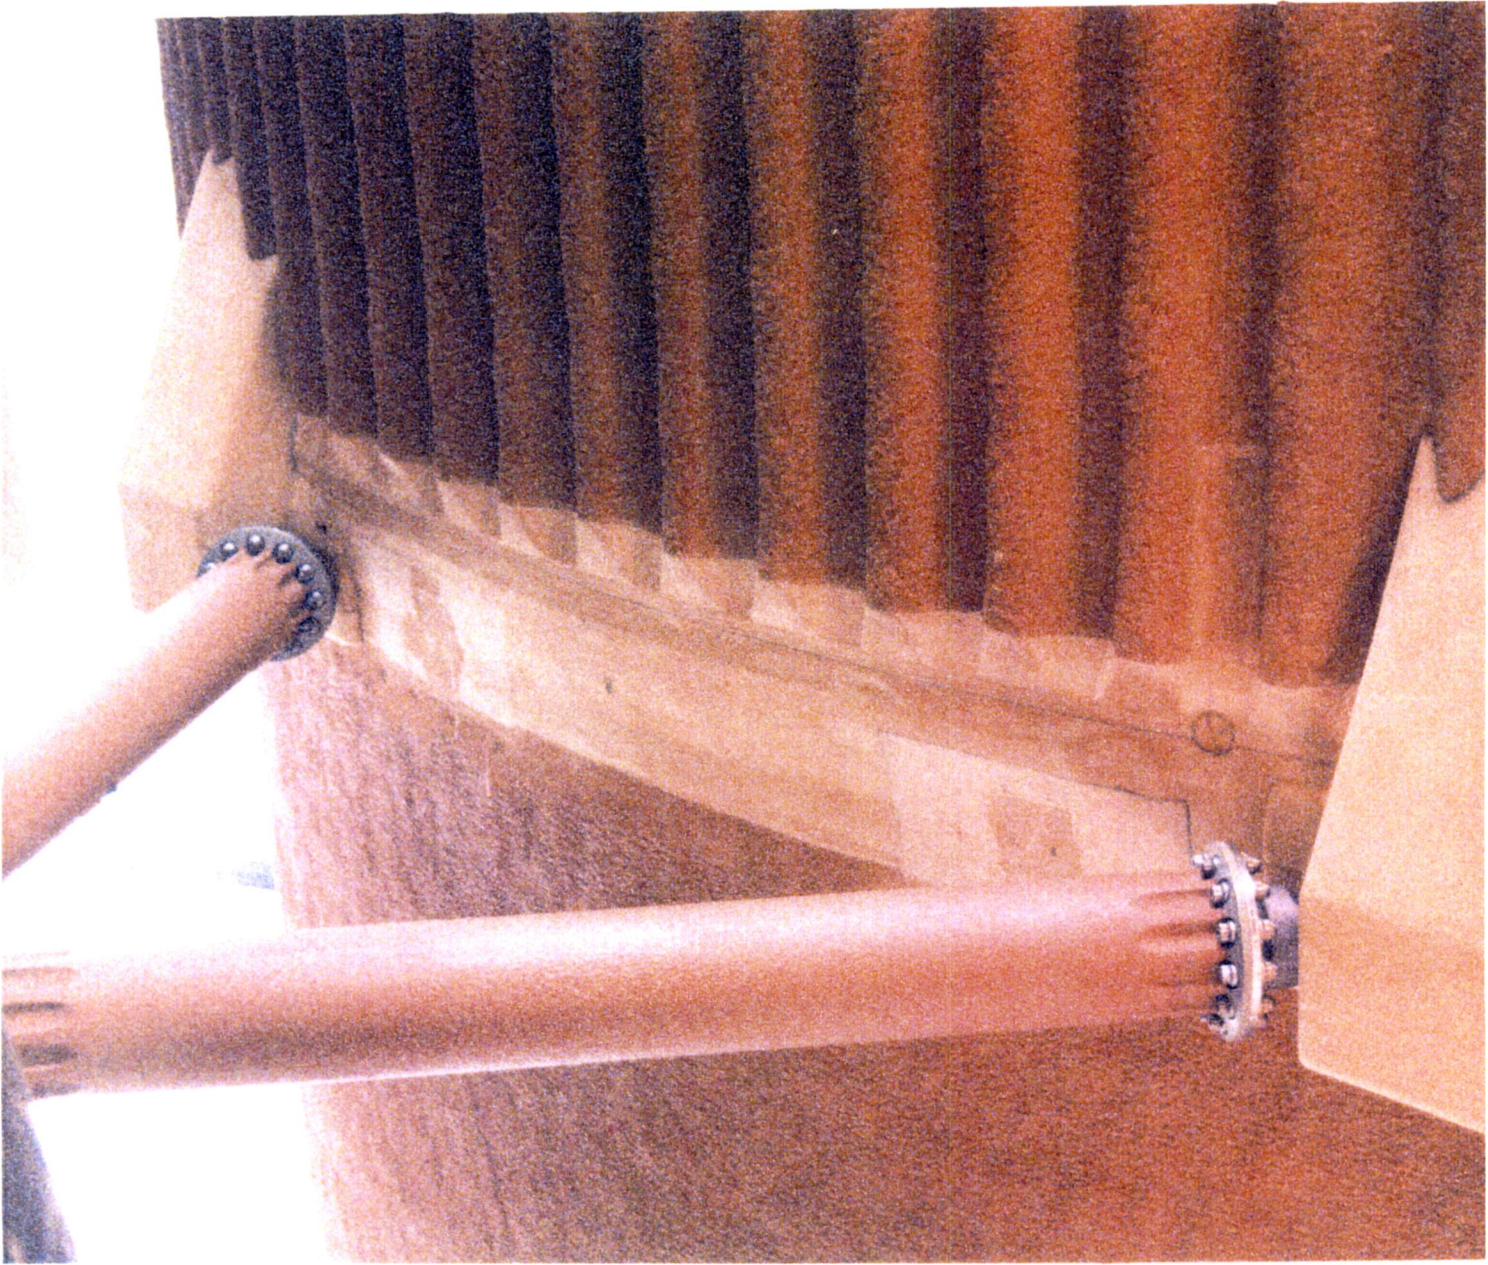
**Photo 6 : Post Drain Condition of Jack Pad Closeouts**

The redesigned bipod jack pad closeouts were intact and flush with adjacent closeout foam

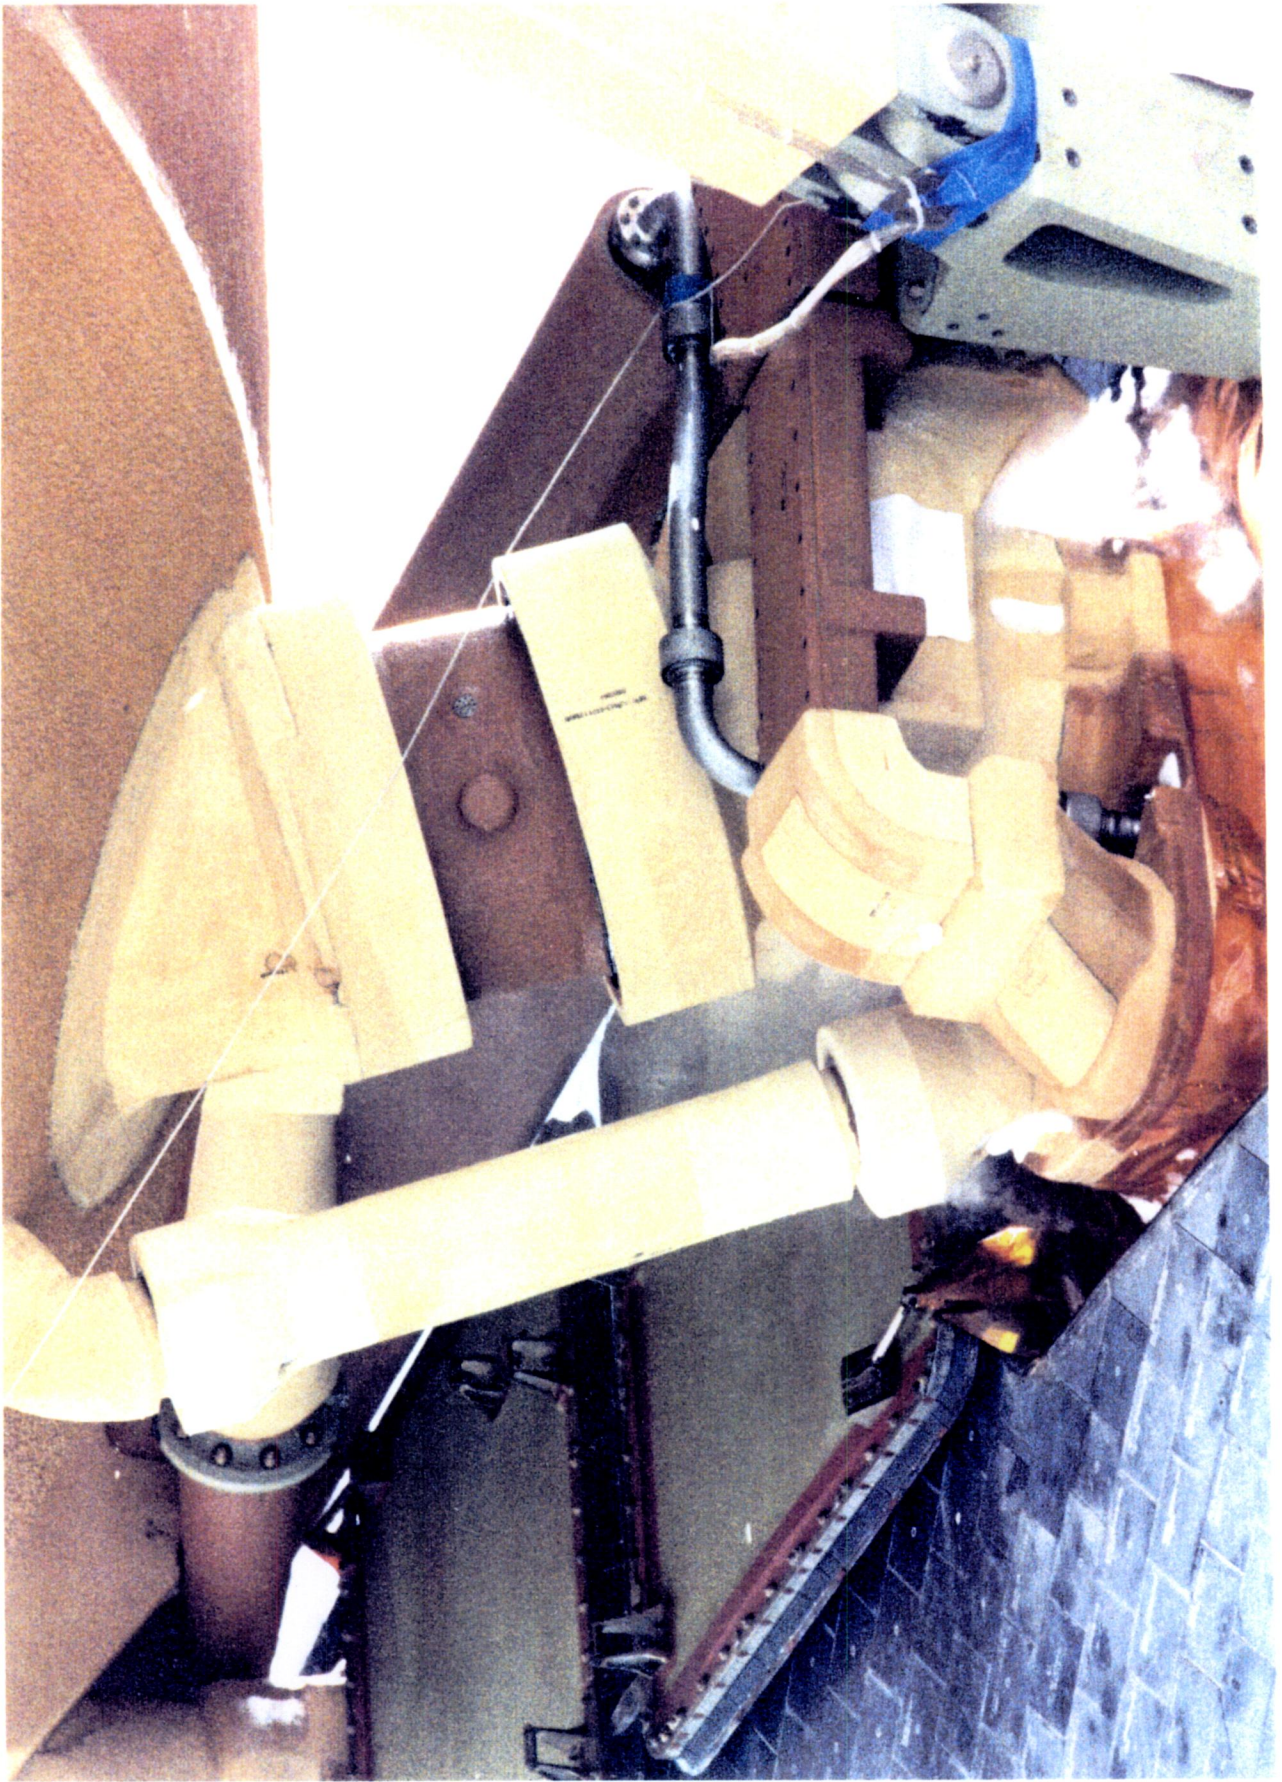
**Photo 11: LH2 ET/ORB Umbilical**

Less than usual amounts of ice/frost accumulated on the LH2 umbilical during cryoload

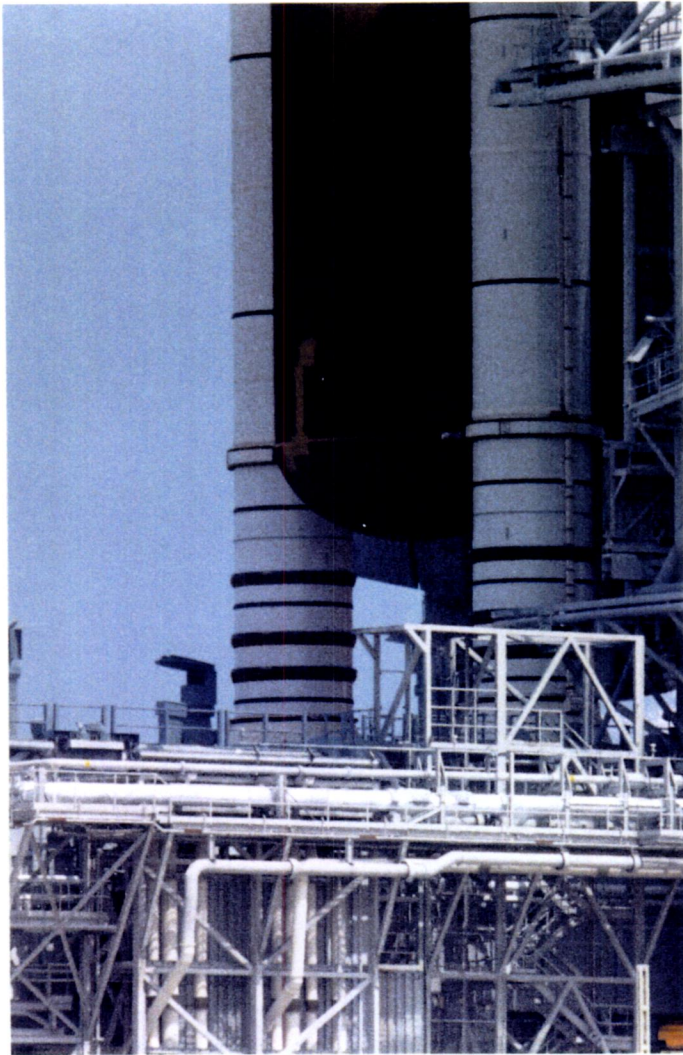
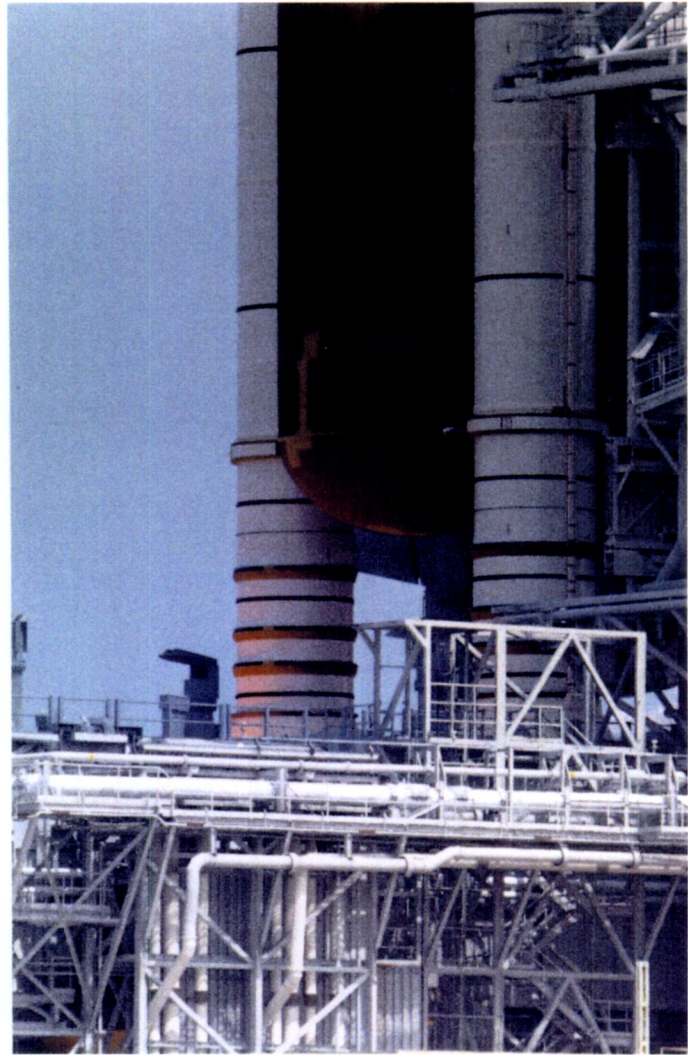
**Photo 15: Flash on RH SRB and ET Aft Dome**

A flash from SRB ignition caused light to be reflected off of the RH SRB aft booster and ET aft dome

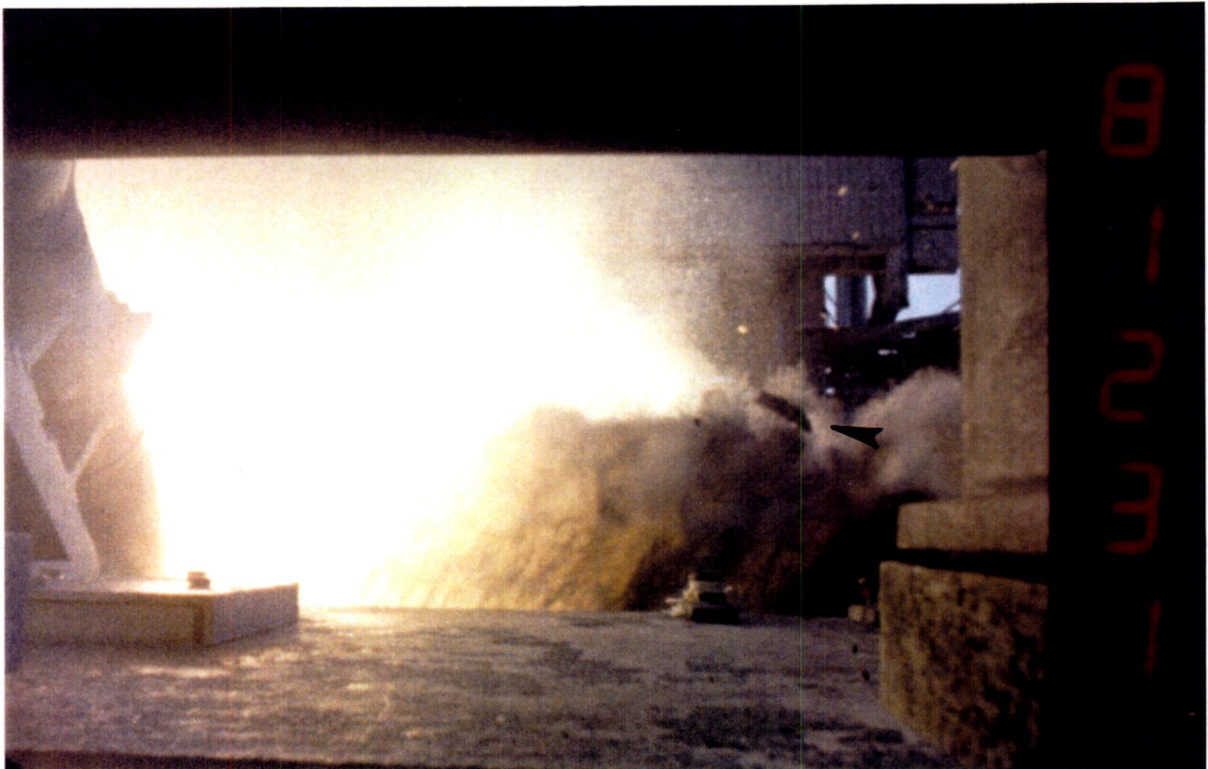
**Photo 16: Debris Ejected from SRB Exhaust Hole**

A rigid object, approximately 7-inches long by 2-inches wide by 1/2-inch thick, was ejected out of the LH SRB exhaust hole near HDP #7 at T-0. The object, which may have been a piece of brick from the flame trench, moved away from the vehicle. The flight hardware was not contacted.

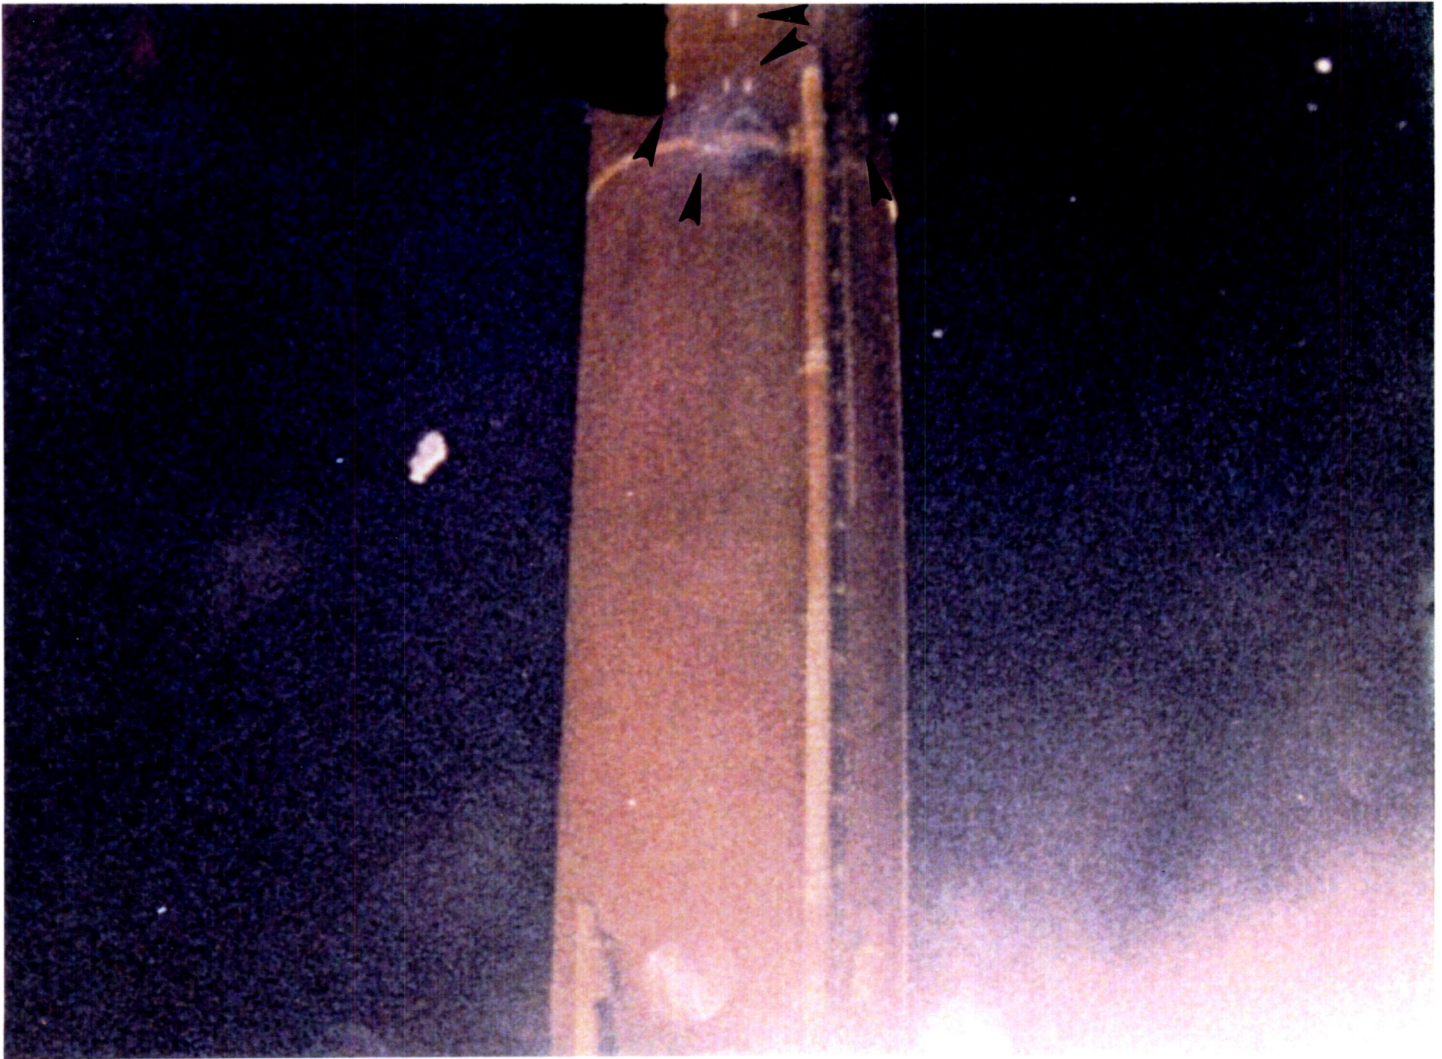
**Photo 20: ET Intertank Divots**

Stringer head divots, ranging in length from 12 to 24 inches, were observed on the intertank acreage: 2 divots forward of the bipods at station XT-1080; 1 divot forward of the bipods on centerline at station XT-960; 1 divot forward of the LO2 feedline fairing at station XT-860; 1 divot forward and outboard of the -Y bipod spindle housing at station XT-1080; and three divots between the LO2 feedline and the +Y EB fitting at station XT-1080. The loss of foam from these intertank divots contributed to the 149 (greater than average) number of hits on the Orbiter lower surface. This type of divot had been the subject of an IFA previously. The redesigned bipod jack pad closeouts were intact. One shallow divot occurred in the LH2 tank acreage aft of the -Y bipod spindle housing closeout.

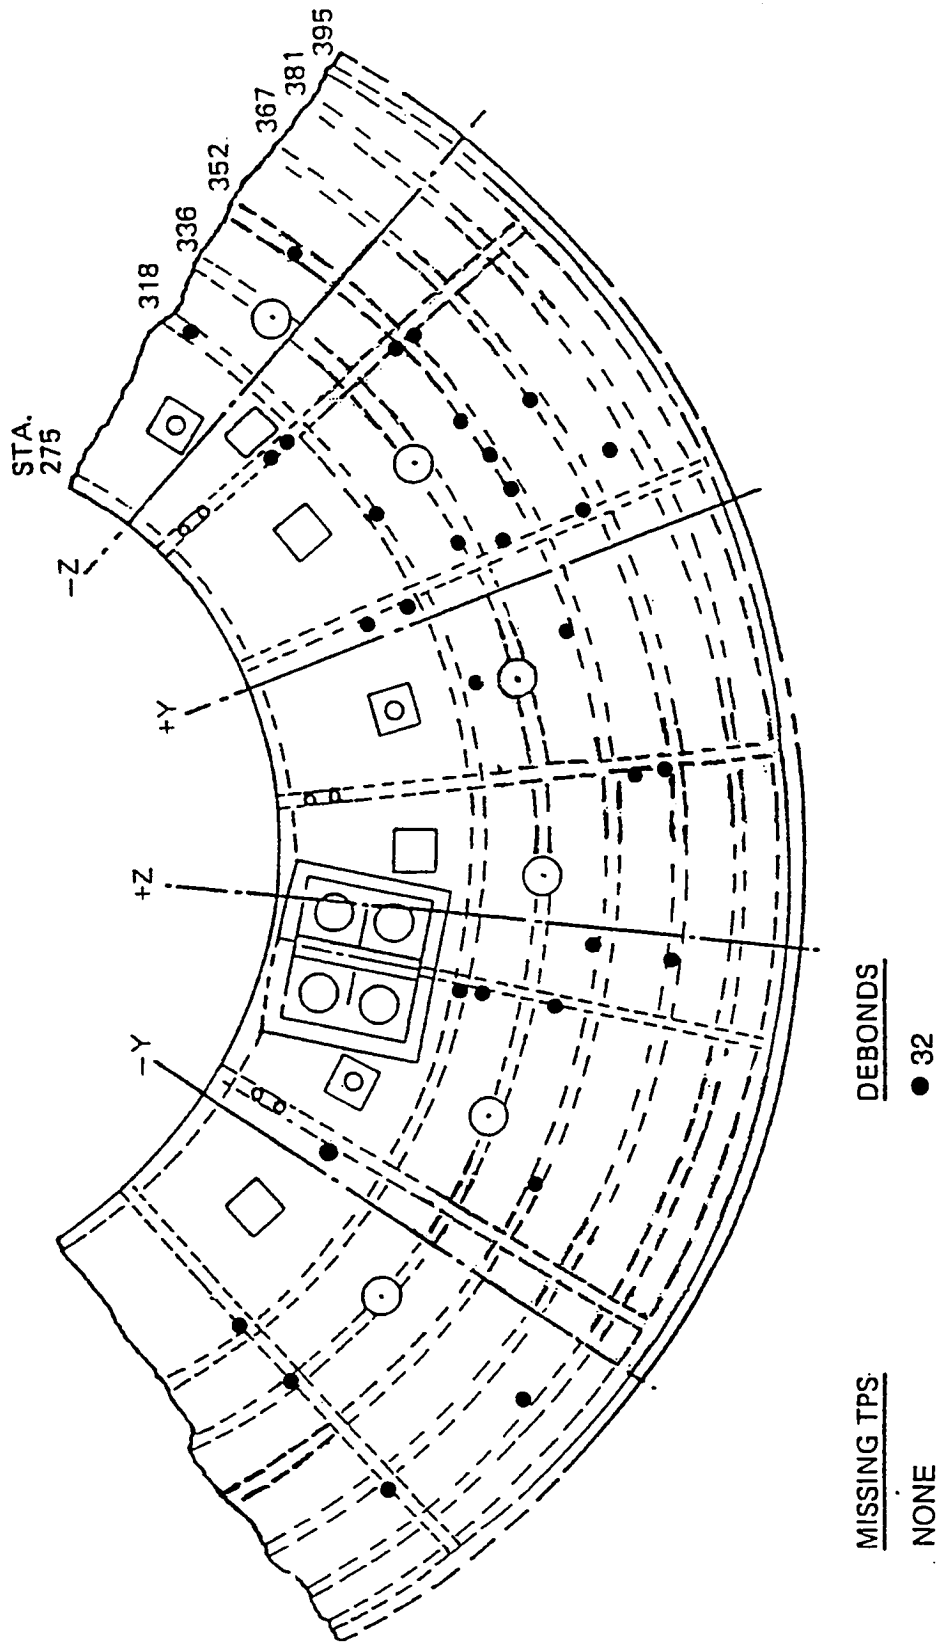
Figure 1 : RH SRB Frustum

The RH frustum was missing no TPS. The number of debonds (32) over fasteners was average (Figure 1). Hypalon paint was blistered/missing along the XB-395 ring frame where BTA closeouts had been applied. Some of the underlying BTA was sooted. The BSM aero heat shield covers had locked in the fully opened position.

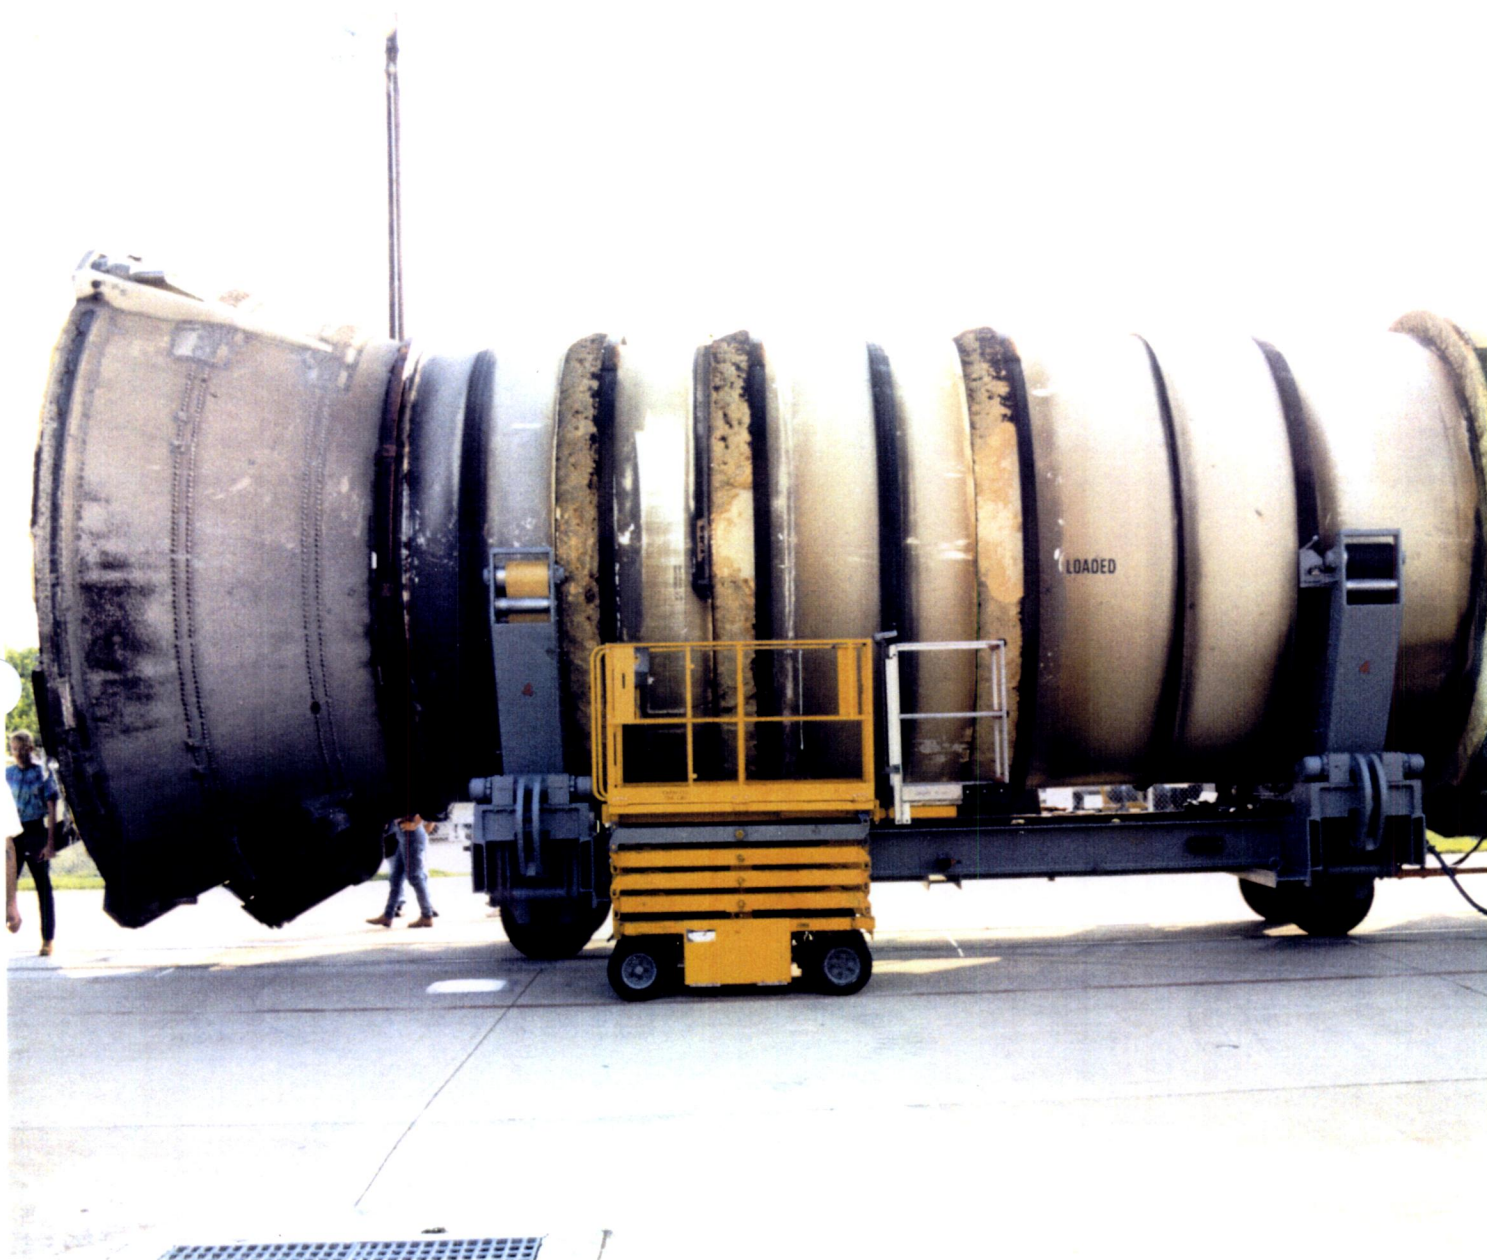
**Photo 22: RH Aft Booster/Aft Skirt**

The phenolic material on the kick ring exhibited typical delamination. Aft skirt MSA-2 was missing from fastener heads in six places. Most of the MSA-2 divots, the largest of which measured 4-inches by 2.5-inches in size, appeared to expose lightly-sooted substrate. Hypalon paint was blistered/missing over the areas where BTA closeouts had been applied. The HDP Debris Containment System (DCS) plungers were seated and appeared to have functioned properly.

Aft skirt MSA-2 was missing from fastener heads in six places. Most of the MSA-2 divots, the largest of which measured 4-inches by 2.5-inches in size, appeared to expose lightly-sooted substrate.

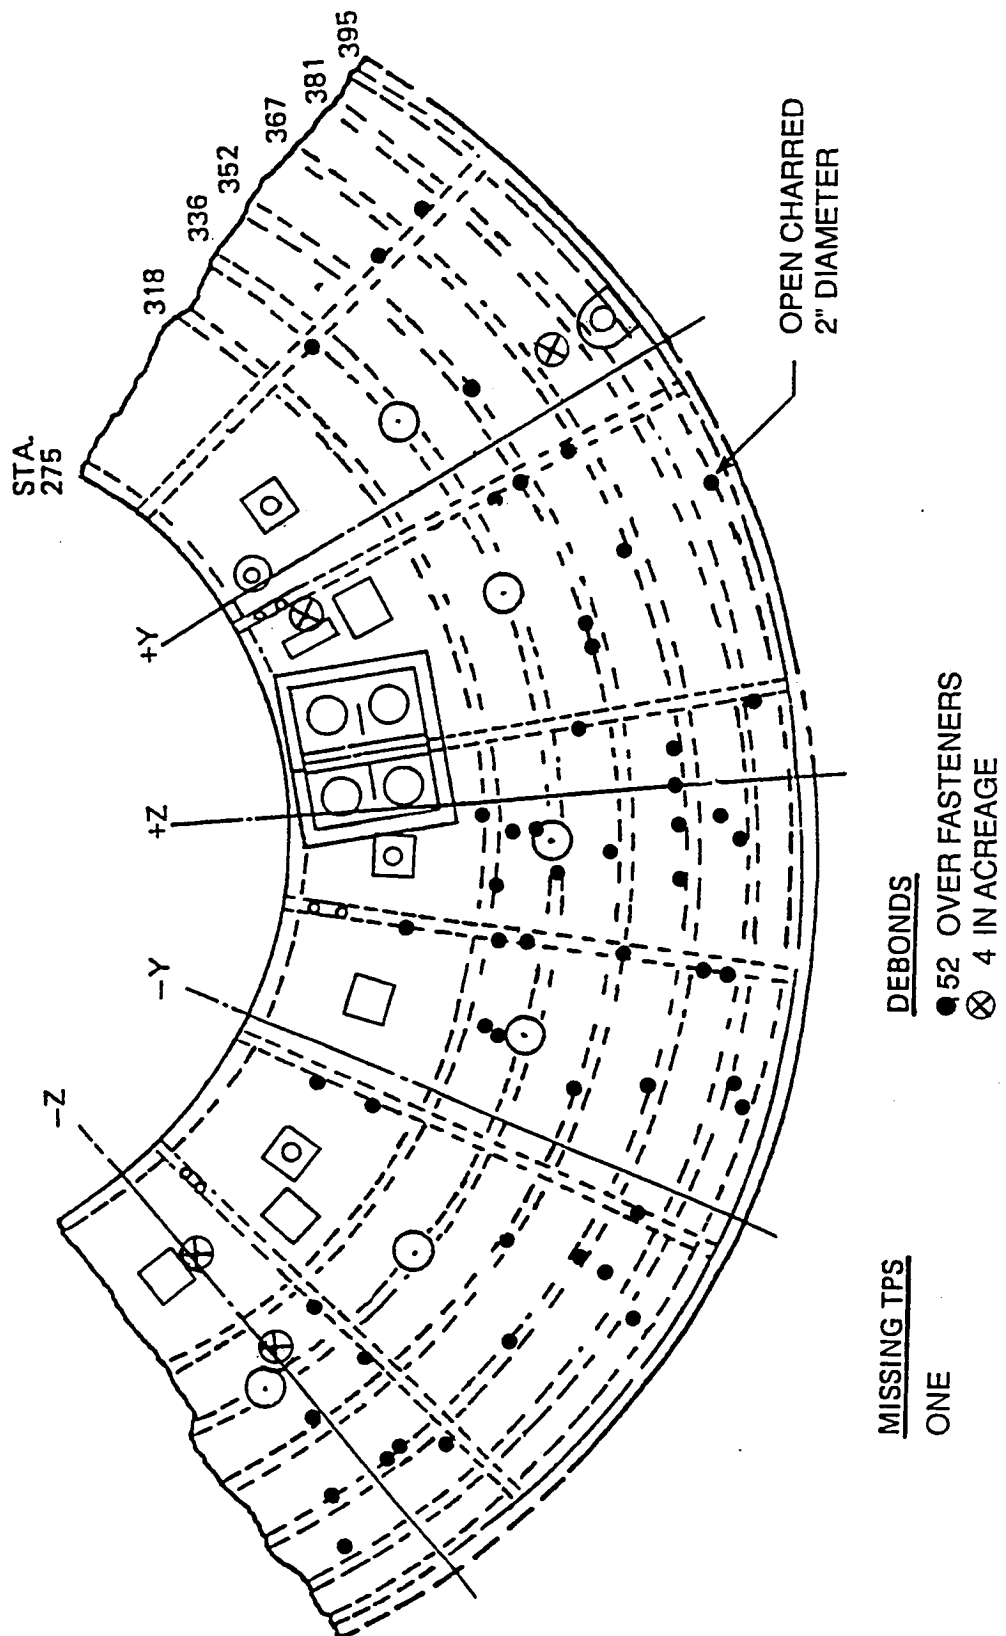
Figure 2 : LH SRB Frustum

The LH frustum was missing one 2-inch diameter piece of TPS (divot) near the XB-395 ring frame between the +Y/+Z axes. The exposed substrate appeared darkened and was sampled (Squawk 71002) for laboratory analysis. USBI Report LAN-031-95MP showed the divot was caused by a debond of the MSA-2 from the PR-1422. The divot occurred after BSM firing (absence of sooting) but sometime during re-entry (heating effects). The number of MSA-2 debonds over fasteners (52) and in the acreage (4) was somewhat greater than average (Figure 2). Hypalon paint was blistered/missing along the XB-395 ring frame where BTA closeouts had been applied. Some of the underlying BTA was sooted. The BSM aero heat shield covers had locked in the fully opened position.

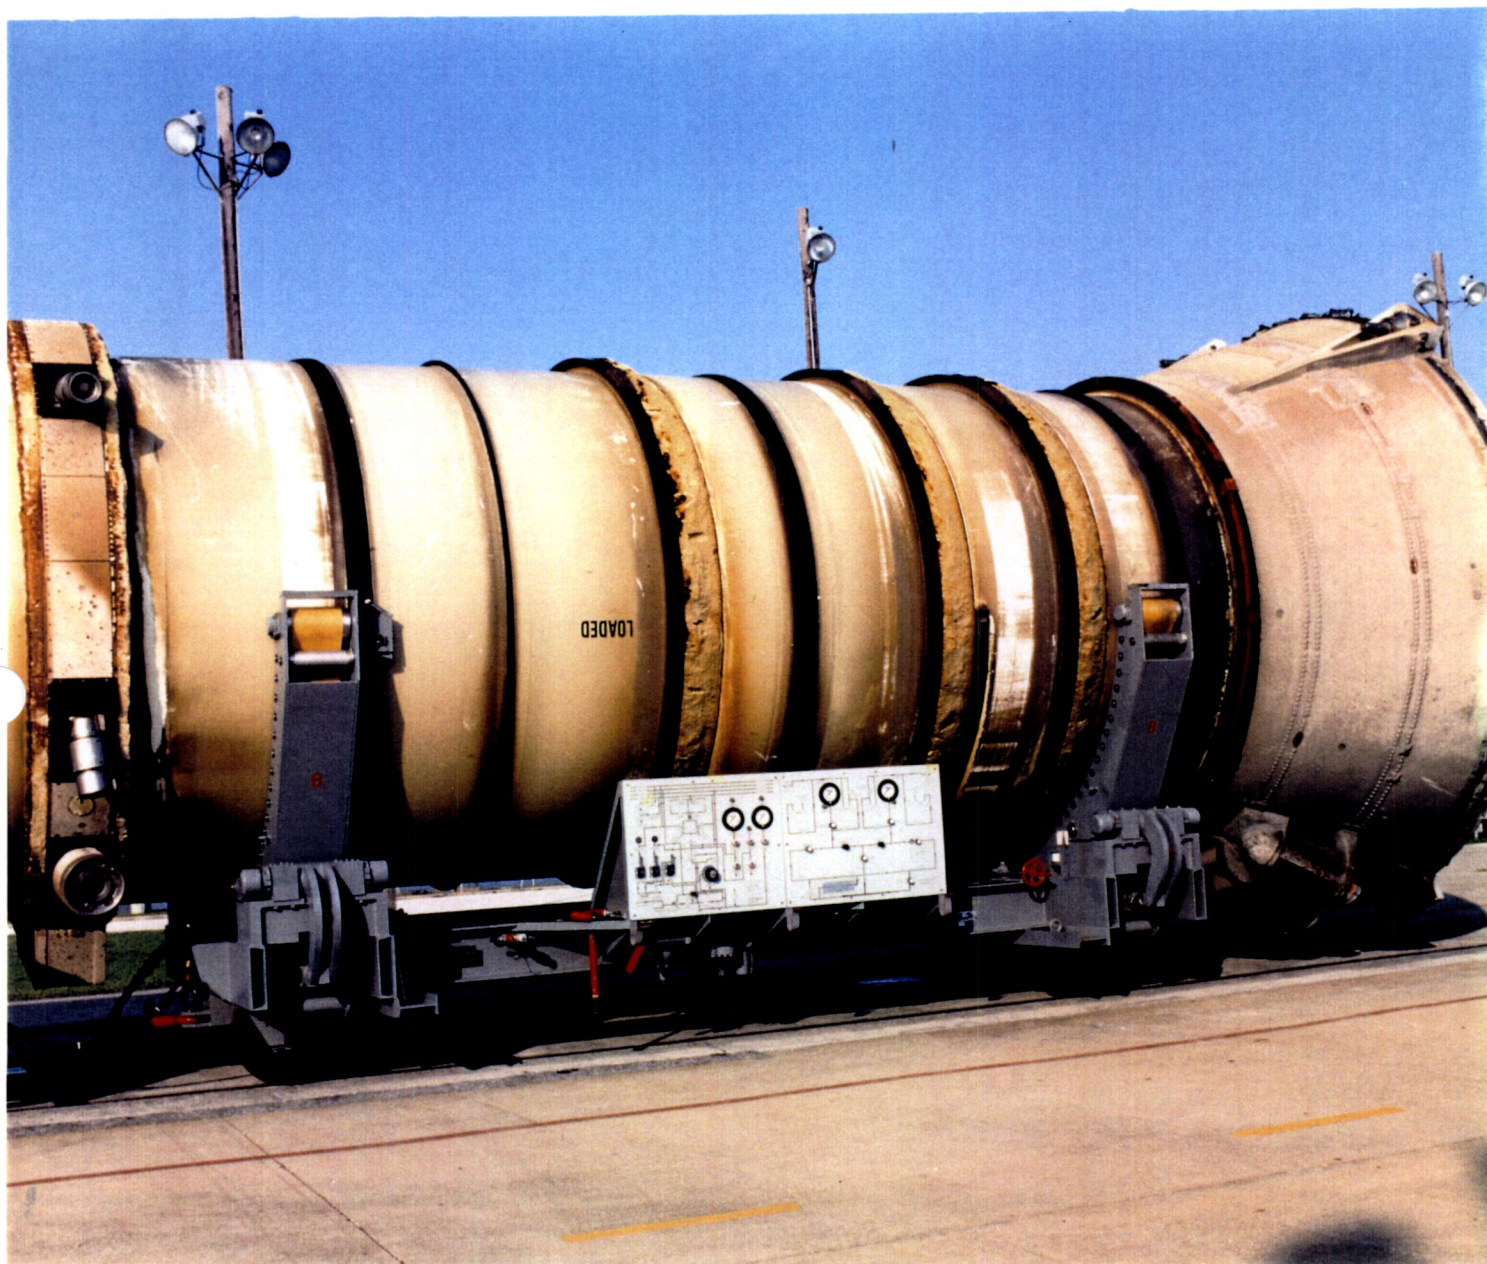
**Photo 25: LH Aft Booster/ Aft Skirt**

The phenolic material on the kick ring exhibited typical delamination. Aft skirt MSA-2 was missing from fastener heads in eight places and debonded in three places. The MSA-2 divots were located along the XB-1860 and XB-1894 ring frames. Hypalon paint was blistered over areas where BTA closeouts had been applied. The HDP Debris Containment System (DCS) plungers were seated and appeared to have functioned properly.

Aft skirt MSA-2 was missing from fastener heads in eight places and debonded in three places. The MSA-2 divots were located along the XB-1860 and XB-1894 ring frames. Hypalon paint was blistered over areas where BTA closeouts had been applied.

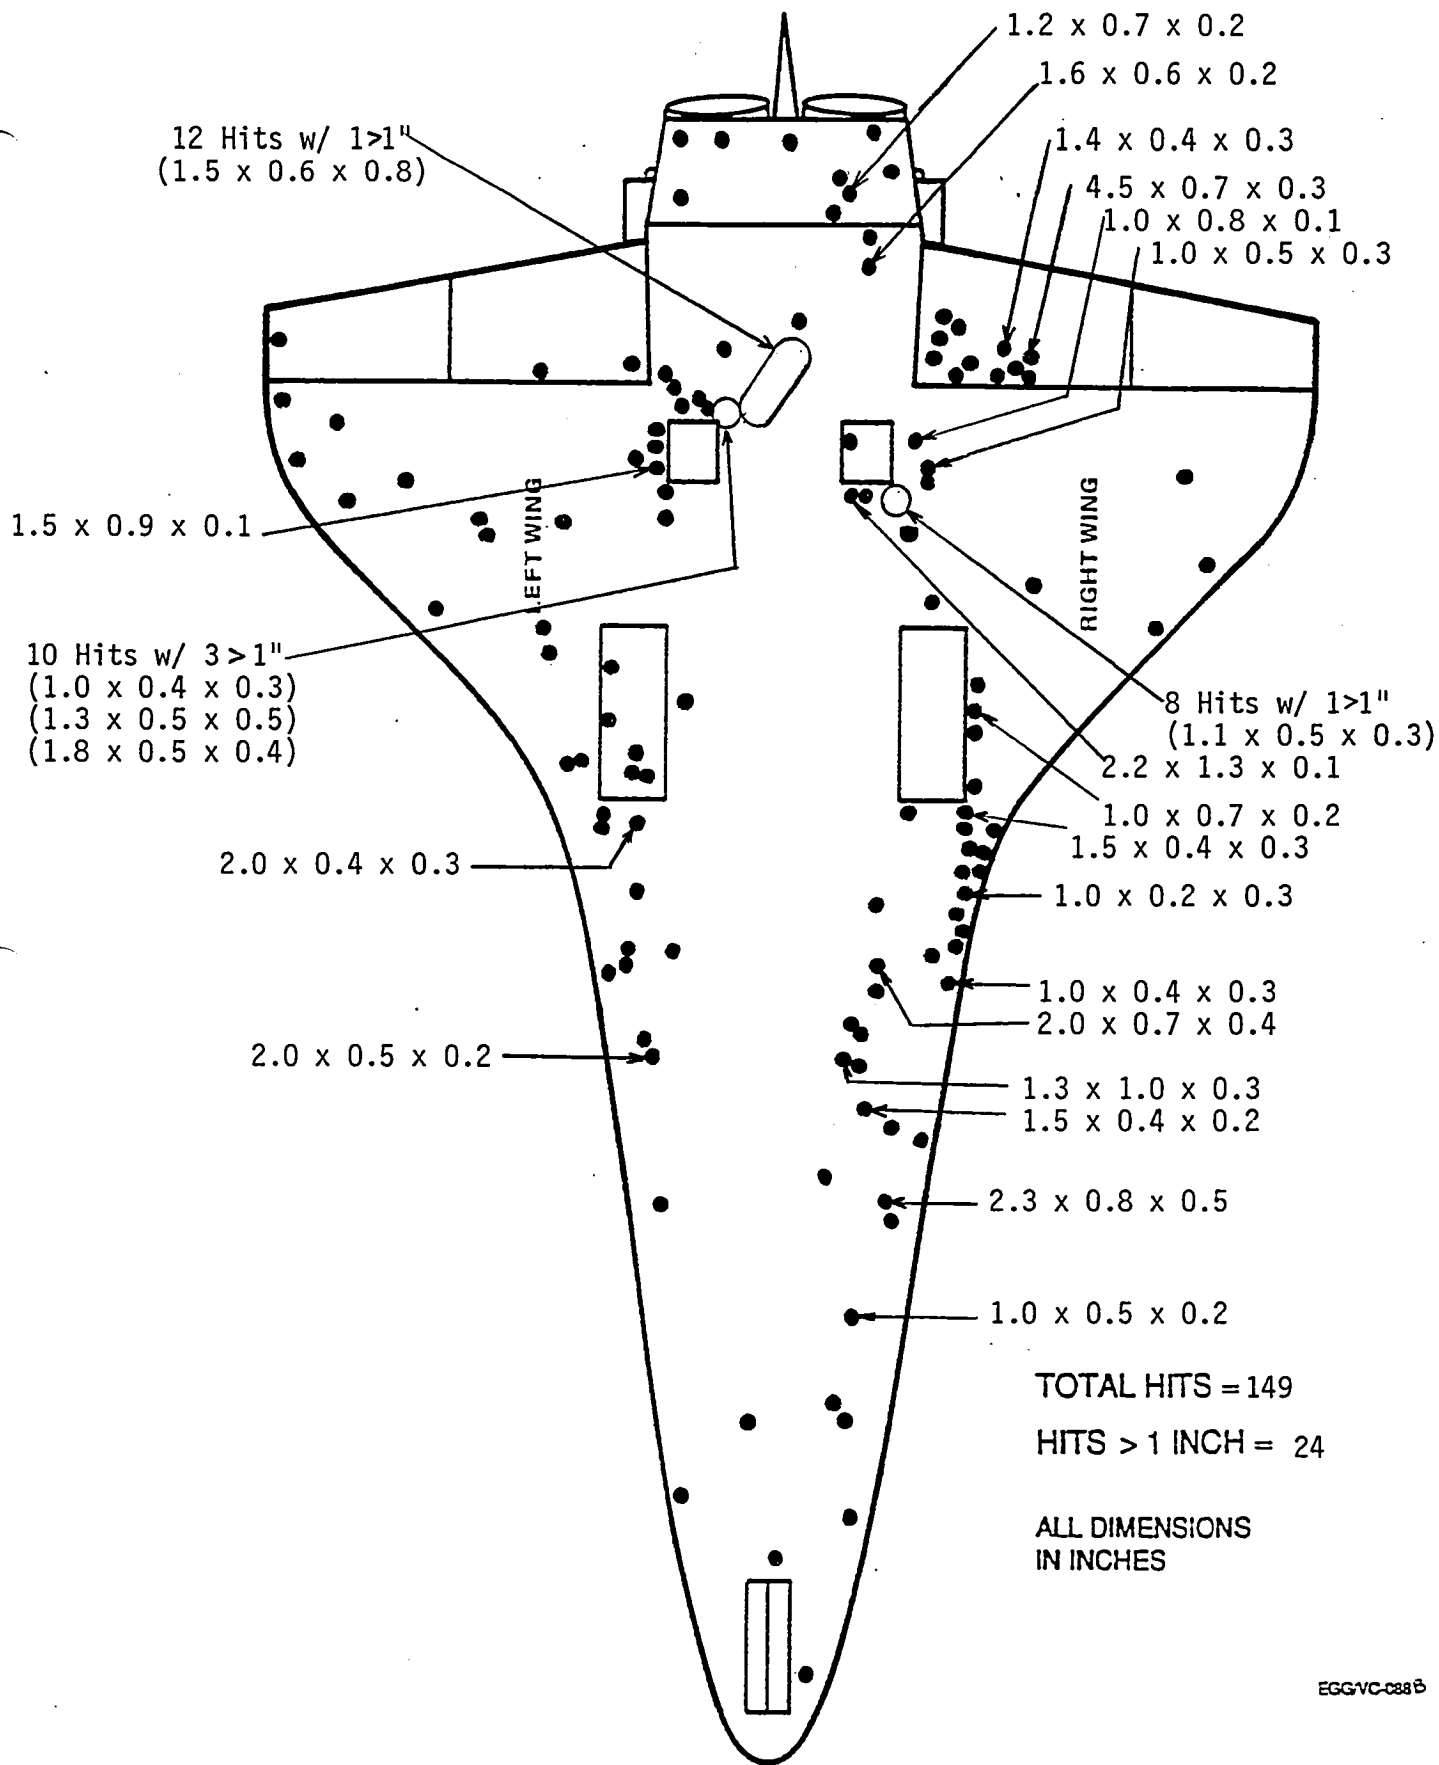
Figure 3 : Orbiter Lower Surface Debris Map

In summary, both the total number of Orbiter TPS debris hits and the number of hits 1-inch or larger was somewhat greater than average when compared to previous missions (Figures 5-6).

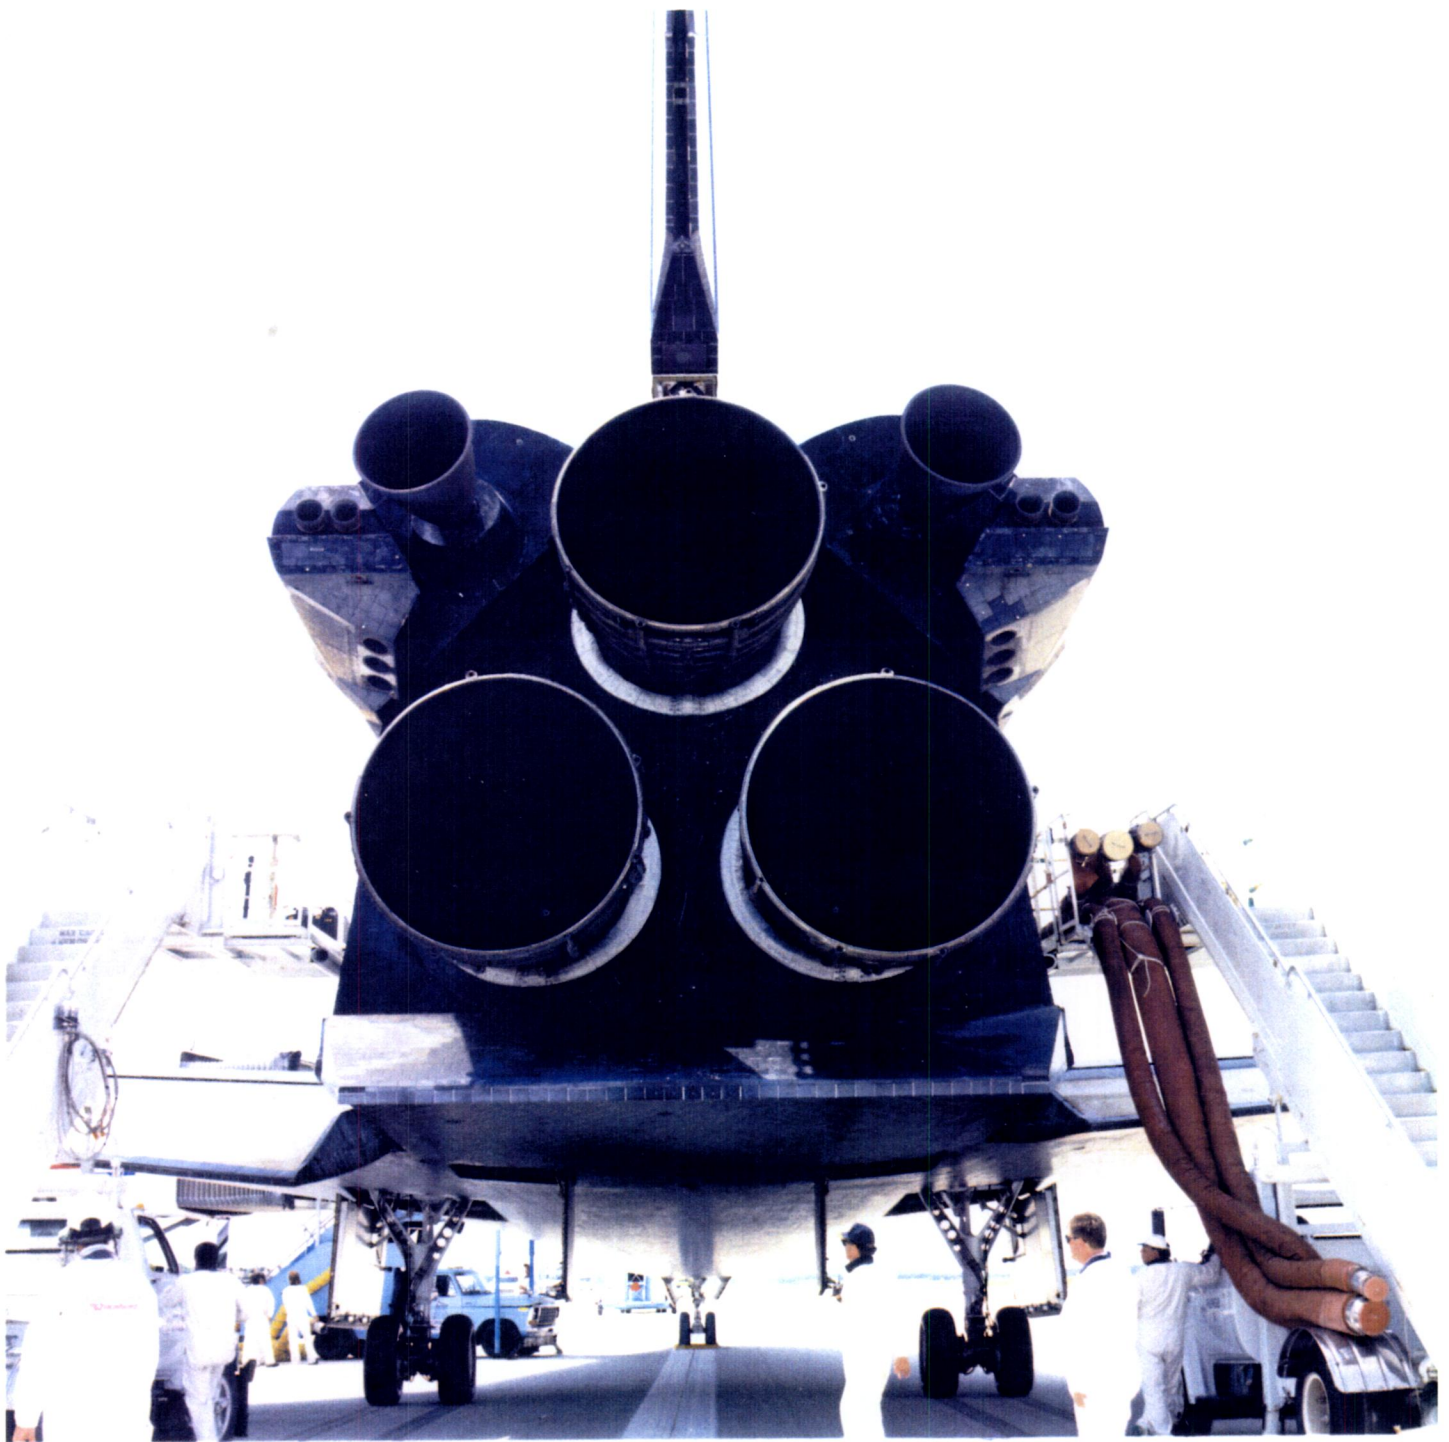
**Photo 30: Base Heat Shield**

Base heat shield tiles and SSME Dome Mounted Heat Shield closeout blankets were in good condition
